**[Docket No. FAA-2013-0822; Directorate Identifier 2013-SW-004-AD;**

**Amendment 39-17783; AD 2014-05-10]**

**Airworthiness Directives; Airbus Helicopters (Type Certificate Previously Held By Eurocopter France) (Airbus Helicopters)**

**SUMMARY:** We are superseding Airworthiness Directive (AD) 2012-25-04 for Eurocopter France Model AS350B3 helicopters with a certain modification (MOD) installed. AD 2012-25-04 required installing two placards and revising the Rotorcraft Flight Manual (RFM). AD 2012-25-04 also required certain checks and inspecting and replacing, if necessary, all four laminated half-bearings (bearings). This new AD retains the previous AD requirements, requires certain modifications which would be terminating action for the airspeed limitations, and adds certain helicopter models to the bearing inspection with a different inspection interval. These actions are intended to prevent vibration due to a failed bearing, failure of the tail rotor, and subsequent loss of control of the helicopter.

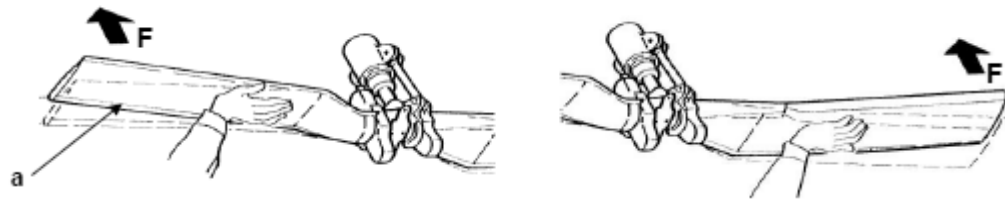
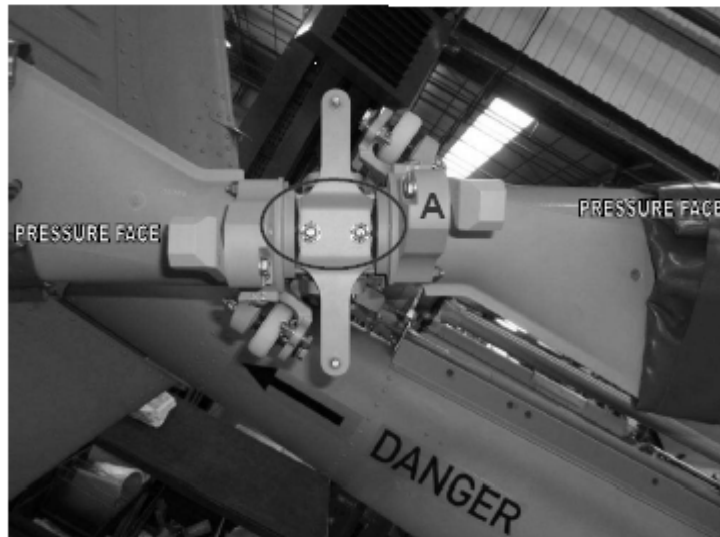
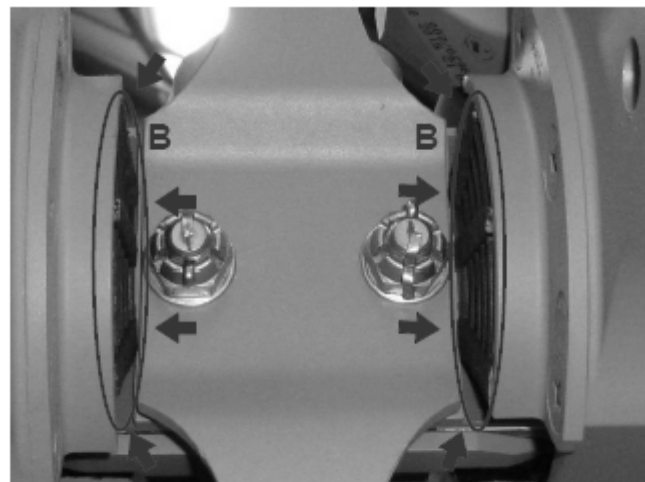
(C) While maintaining the load, check all the visible faces of the bearings (front and side faces) in area B of DETAIL A of Figure 3 to paragraph (f) of this AD for separation between the elastomer and metal parts, a crack in the elastomer, or an extrusion (see example in Figure 4 to paragraph (f) of this AD). A flashlight may be used to enhance the check.

(v) If there is an extrusion on any bearing, before further flight, replace the four bearings with airworthy bearings.

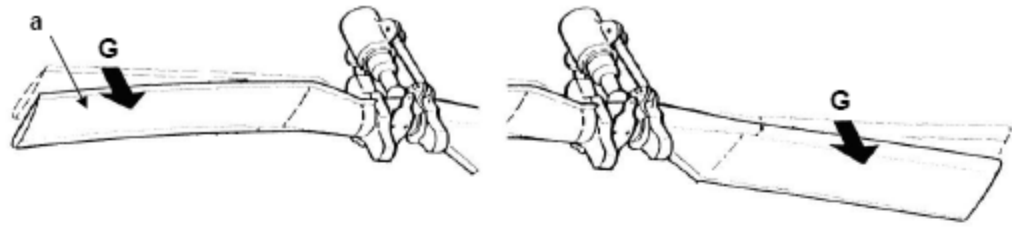
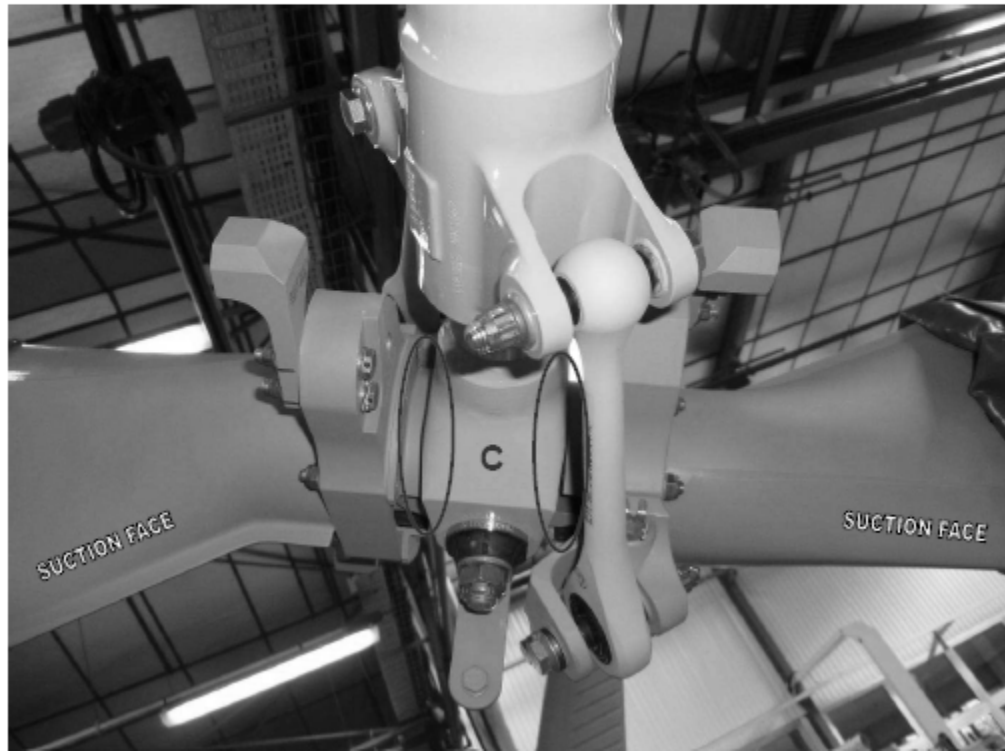
(F) While maintaining the load, check visible faces of Area C as shown in Figure 5 to paragraph (f) of this AD for any extrusion. A flashlight may be used to enhance the check.

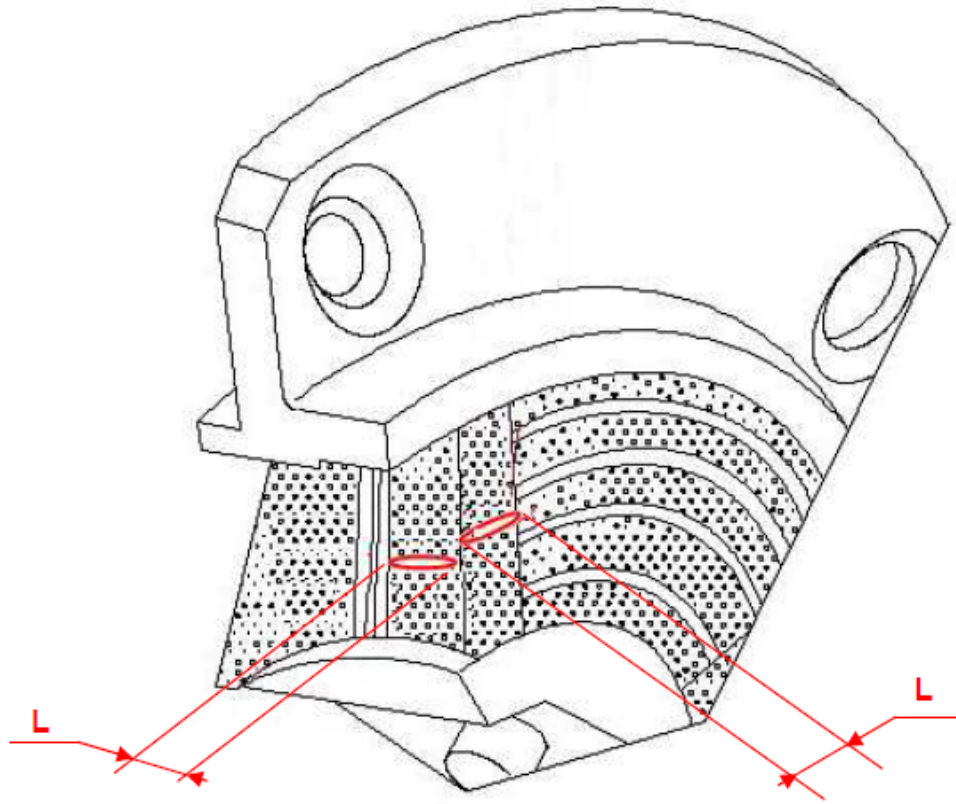
(vi) If there is a separation or a crack on the pressure side bearing, measure the separation or the crack. If the separation or crack is greater than 5 millimeters (.196 inches) as indicated by dimension “L” in Figure 6 to paragraph (f) of this AD, before further flight, replace the four bearings with airworthy bearings.
